Dam ID: HI00066  
LOWER ANAHOA

STATE OF HAWAII - DLNR  
DAM SAFETY INSPECTION SHEET

Inspection No: \_\_\_\_\_  
Date: 4/8/06

Inspection Type: Dam Safety Inspection

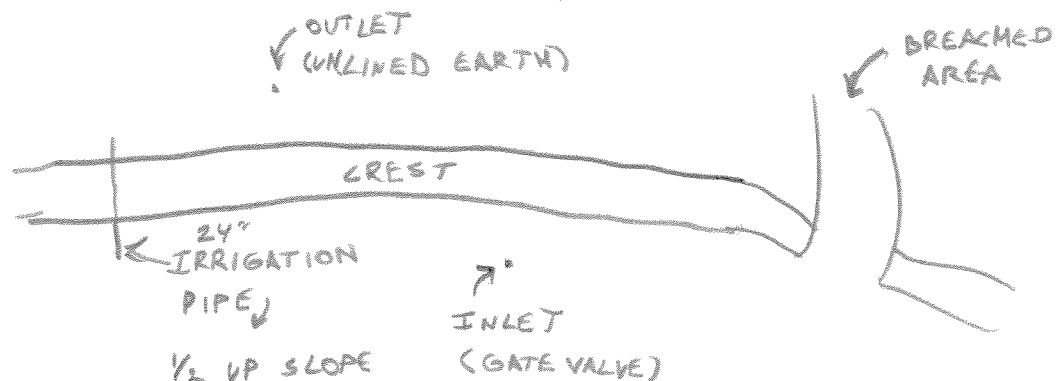
Type / Size: SEE SKETCH  
GATE VALVE ENTRANCE - UNSURE OF SIZE OF PIPE - EARTH LINED

- ☐ j. UNSURE OF HOW INLET (CULVERT) & OUTLET (UNLINED EARTH) ARE CONNECTED  
IRRIGATION DIVERSION PIPE APPEARS TO BE RARELY USED. TOO HIGH ON D  
NO ACCESS TO OUTLET WORKS GATE VALVE.
